Chumaduthangi (Load Relieving Stones) of Thalappilly Taluk in Thrissur District, Kerala, India

ARYA P. N., ANANTHU V. DEV, RAJESH S. V. AND ABHAYAN G. S

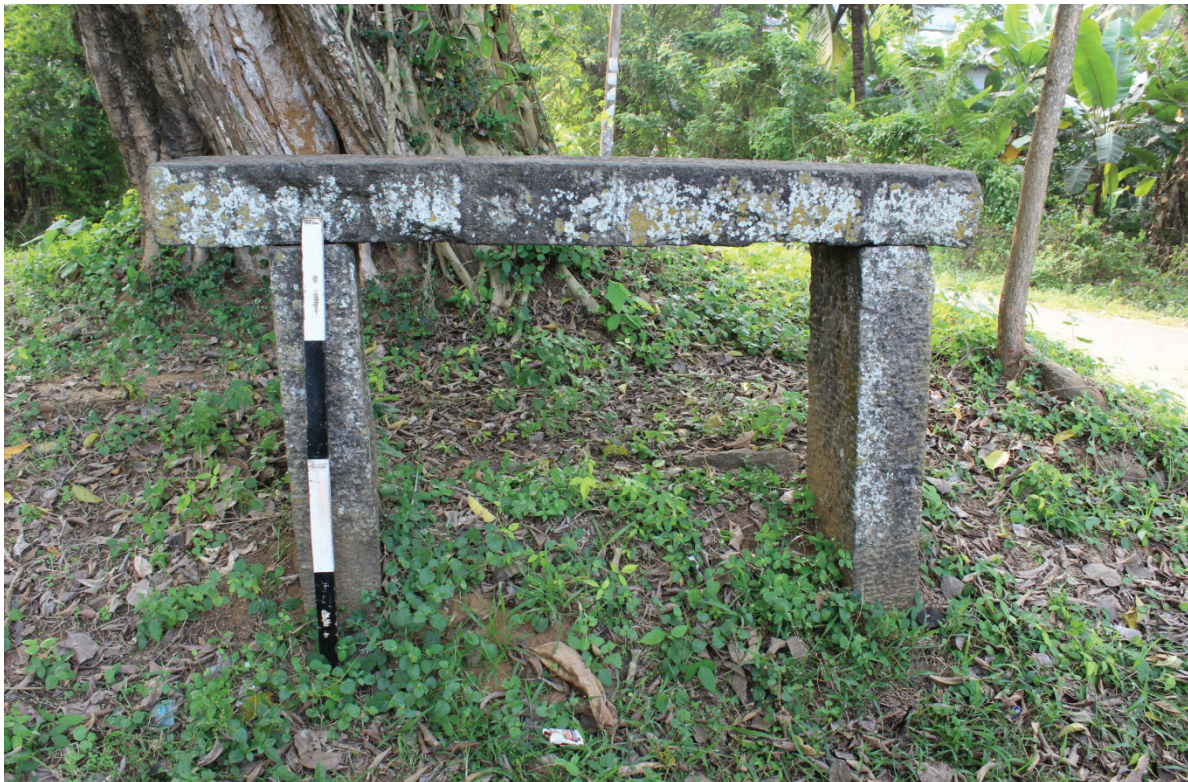
Figure 3. Two pillar Chumaduthangi, Venganelur

In Thalappilly *chumaduthangi* is mostly made out of charnockite rock but laterite stones can also be seen. Architecturally it resembles a stone bench or table i.e.; one or two dressed rectangular horizontal slabs placed on two or three dressed rectangular vertical stone pillars (Figs. 3 and 4). The tallest among them has a height of 2m and the longest among them has a length of 5.5m. During the exploration only one *Chumaduthangi* made of laterite was found in broken condition (Fig. 5). Most of the *Chumaduthangi* contain inscriptions, simple artworks and symbols on them. Most common symbol is that of a flower (Figs. 6 and 7). It has been found at the edges or at the centre of the horizontal slab. Fingers pointing towards left and right sides of the inscription are present

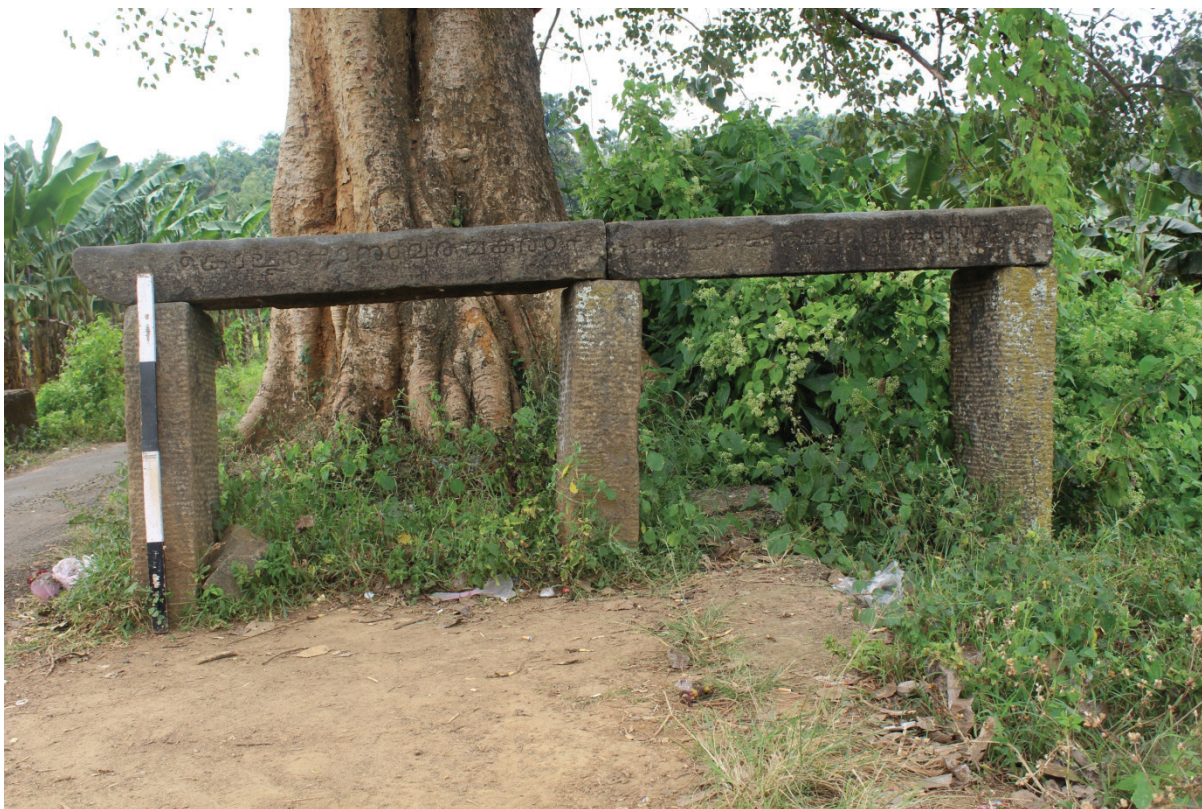
Figure 4. Three pillar Chumaduthangi, Pilakkode

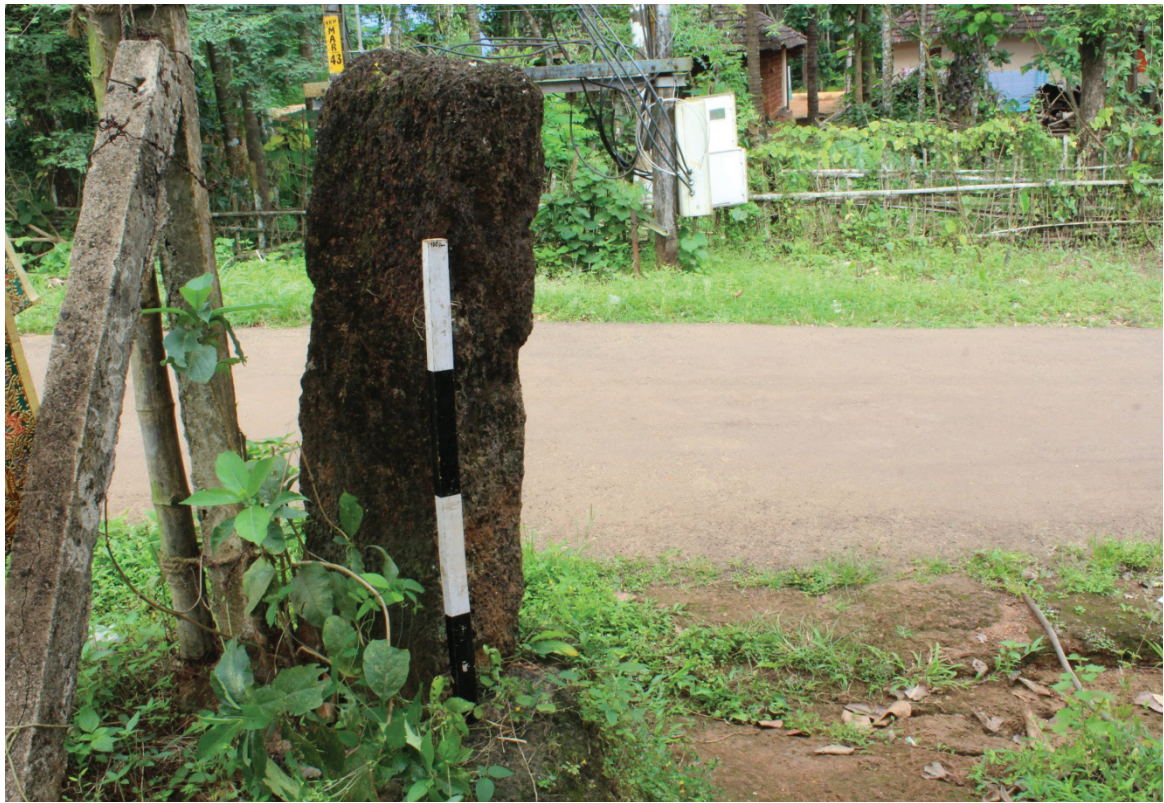
Figure 5. Broken laterite Chumaduthangi, Eyyal Parappuram

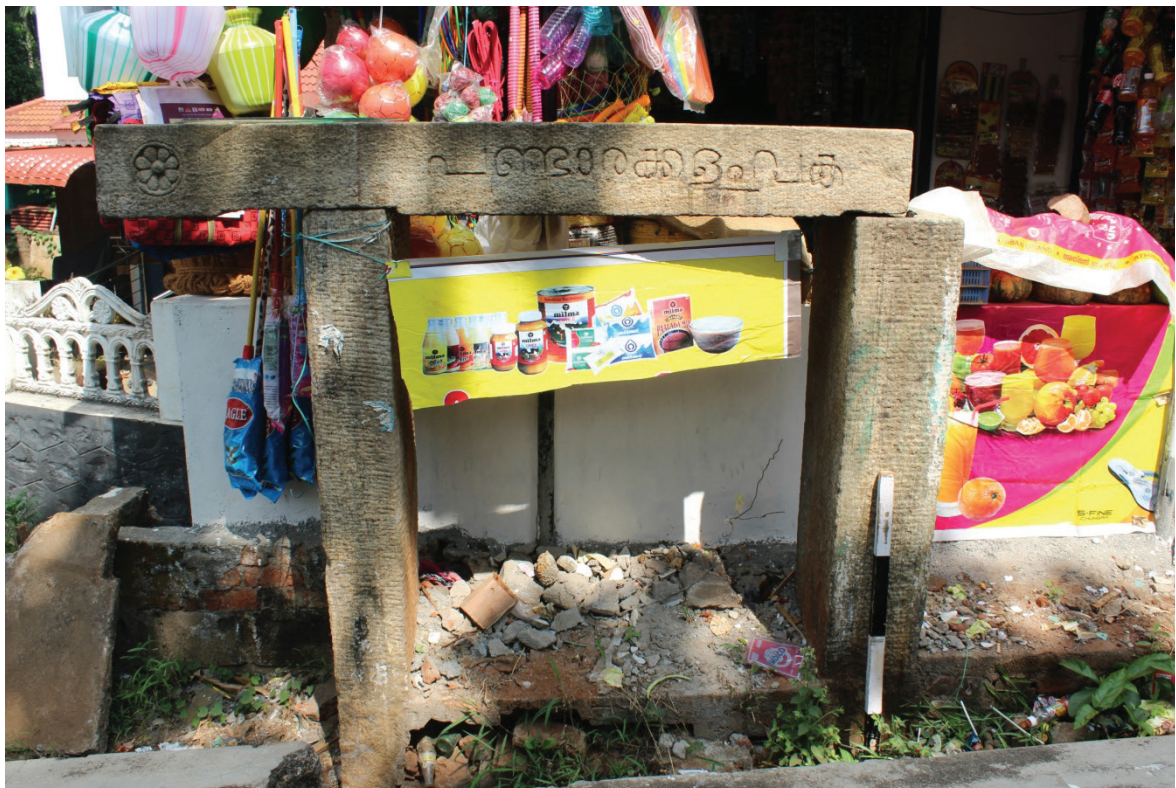
Figure 6. Chumaduthangi having flower symbol and Inscription, Kootupaata

It was seen that 34 *Chumaduthangi* have small inscriptions and many of these are legible. The inscriptions are engraved on horizontal stone blocks and the script used is the old Malayalam (Fig. 6). These valuable sources provide information about the year, month, name of the donor, name of his/her house and lineage. It was observed that the donors are mostly men. In some instances, name of females can be seen, which indicate that particular structure was erected by or on behalf of a lady whose name is inscribed on it. According to popular belief in early times, such donations were made by woman for avoiding risks during pregnancy (Jenee Peter: Personal communication). From the donor's names mentioned in the inscriptions it is noted that in Thalappilly, the *Chumaduthangi* were erected by the Hindu community only. In other places of Thrissur district constructions by the Christians and Muslims can also be seen.

Though many of the *Chumaduthangi* in the study area are in good state of preservation; nowadays majority of the monuments are mainly misused by the political parties and locals to tie banners (Fig. 6) and to paint them for advertisement purposes (Fig. 9). Some people have used the broken stone slabs of *Chumaduthangi* for construction purposes as well. Some of the *Chumaduthangi* are in inaccessible condition due to vegetation growth and soil deposition. In many places *Chumaduthangi* are absent but the place name such as Poovathani (Poovathani derived its name from *Athani* or *Chumaduthangi* which had engravings of flower symbols on it) suggests the presence of them.

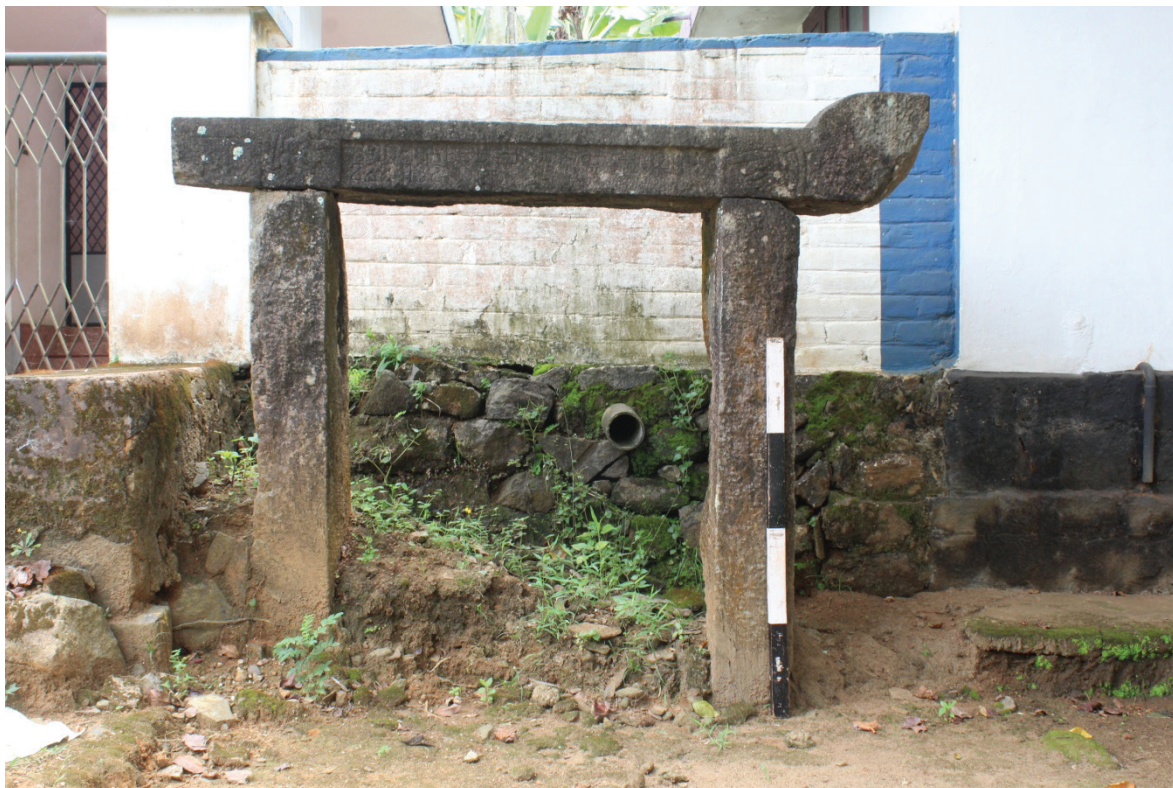
Figure 8. Chumaduthangi having Palm symbol and semi curved portion, Thichur

in the structure at Thichur (Fig. 8). In some of the *Chumaduthangi* one side of the horizontal slab has

a semi curved portion (Fig. 8) and the purpose of the same is apparently for decoration. Rarely present small conical step like projections on the vertical pillars seem to be meant for climbing on top of the horizontal block (Fig. 9).

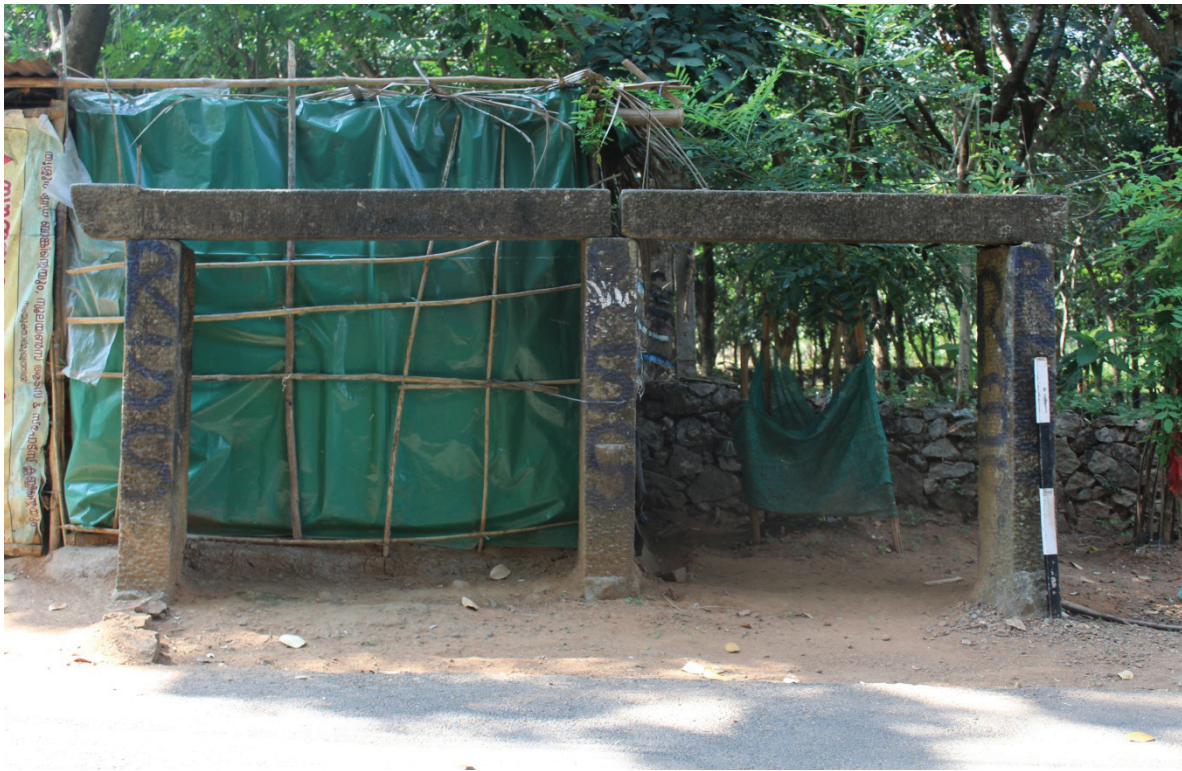
Figure 9. *Chumaduthangi* having projection to climb, Pallimukku

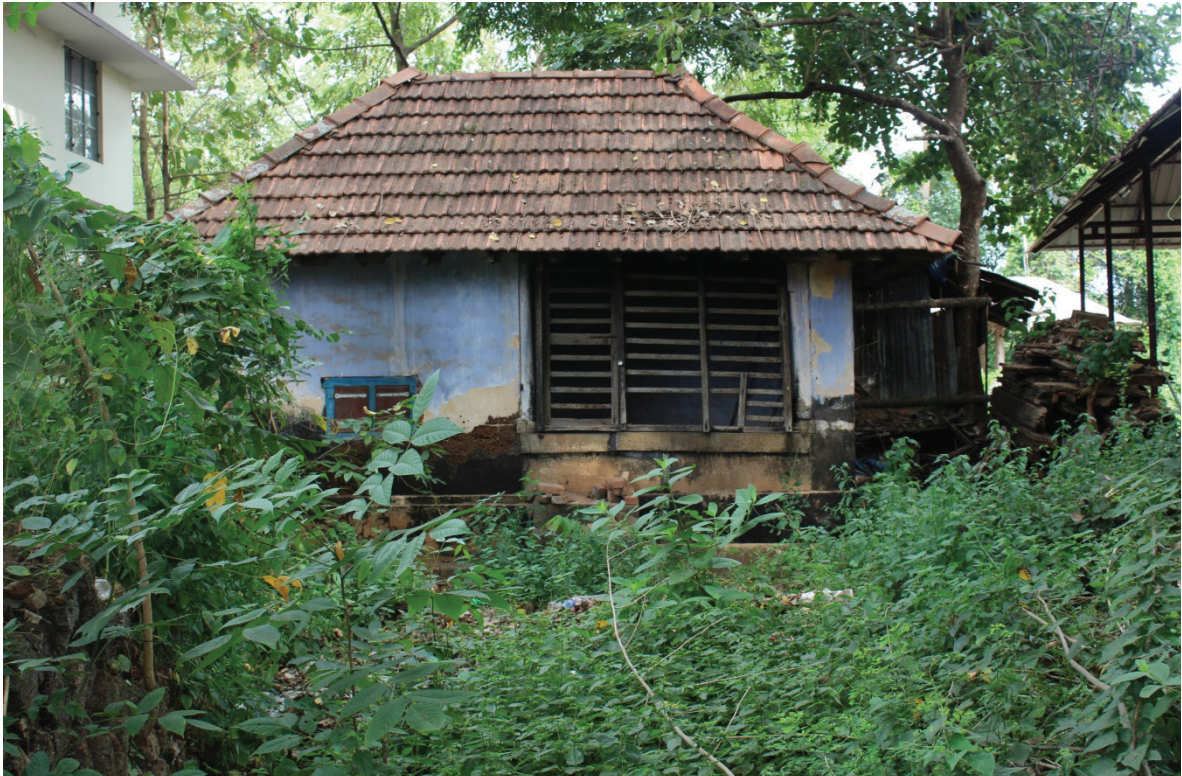
Figure 11. *Vazhiyambalam* at Chelakkara

In Thalappilly taluk, majority of the *Chumaduthangi* are found alone in most of the areas, while two are found in associated with *Vazhiyambalam*, locally known as *Thanneer panthal*. One is located at Chelakkara and the other at Pazhayannur. The *Vazhiyambalam* is a structure made of bricks and laterite blocks, to be used as a resting place for the people who travel long distances and carry commodities. It is a single roomed structure with two pillared veranda and a gabled roof. These were constructed and maintained by the upper class families or royal families of the respective periods. The oral tradition says that the travellers kept their luggage on *Chumaduthangi* and took rest in the *Vazhiyambalam*, where they could get drinking water and refreshments like butter milk. In the study area, the *Vazhiyambalam* look like small residential structures and they appear to be renovated and hence appear much later in date. The *Vazhiyambalam* at Chelakkara is partially

collapsed (Fig. 11). The other one located at Pazhayannur (Fig. 12) is presently functional during the festival at Pazhayannur Bagavathi temple. The *Chumaduthangi* are also found associated with *Karinkalthotty*, a basin like vessel made out of a single granite stone block. It was apparently used to provide water for domestic animals such as cattle. *Karinkalthotty* was reported from Vadakkethara and Pazhayannur.

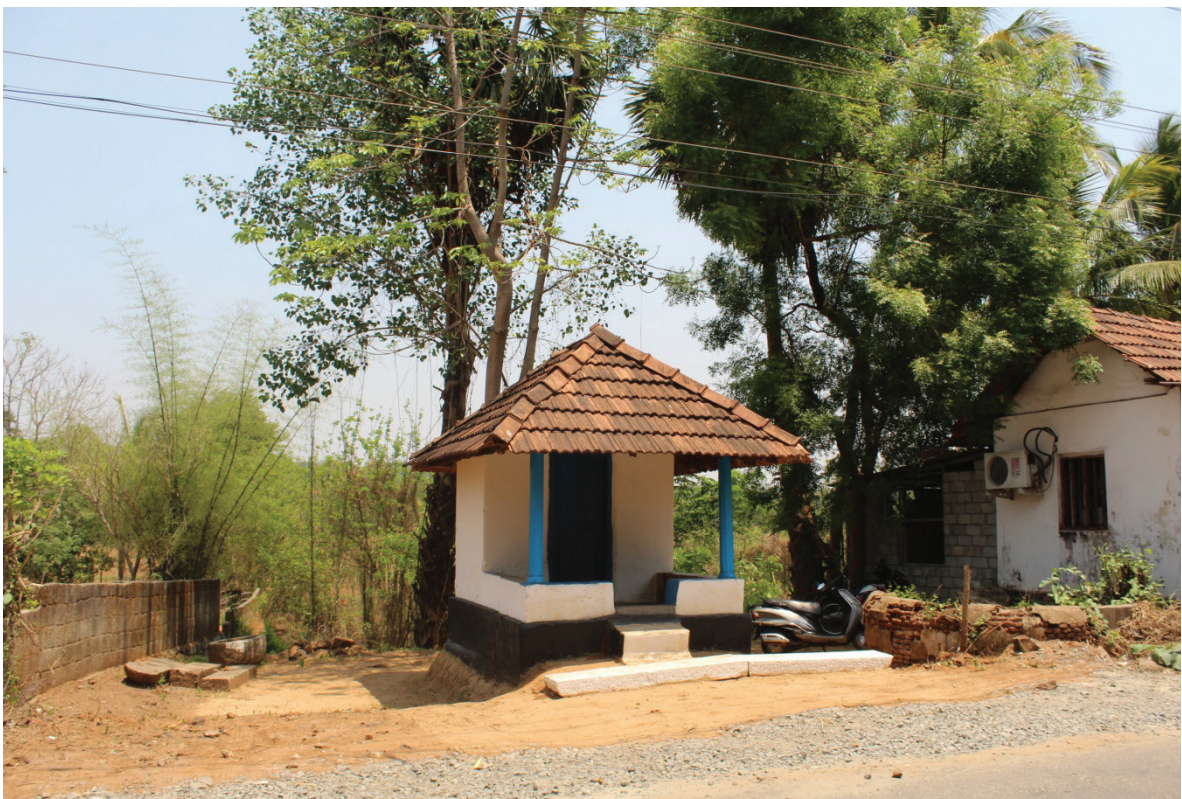
Figure 12. *Vazhiyambalam* at Pazhayannur
