# Derawar Fort Cholistan- History, Architecture, Conservation

Humaira Nazir

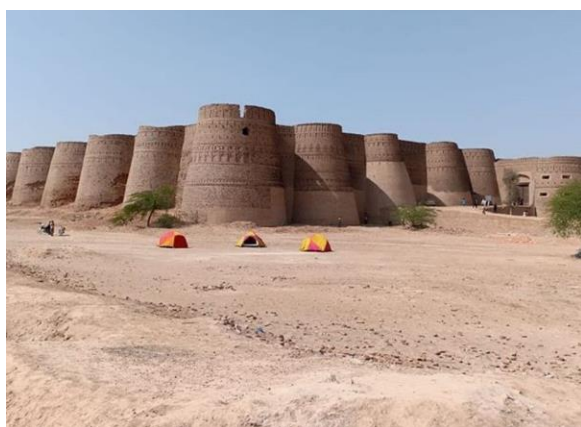
Figure 5: Derawar Fort with giant round 40 buttresses (bastions) measuring 40 meters (130 feet) high, dominating the landscape of Cholistan desert (Source: Author)

The Derawar fort, approximately 130 kilometres south of Bahawalpur (Figure 03 and 04), is a spectacular, huge, and well-known historical site that rises out of the surrounding Cholistan desert and can be seen from afar (Figure 05). It is owned by the Abbasi family. This fort is prominent because it dominates the Cholistan desert skyline. According to common belief, this fort was titled Derawar after the founder, Dev Rawal. Historians and archaeologists think Derawar is one of the Cholistan deserts' earliest inhabited locations. In the 9th century, Rai Jajja Bhatti, a Rajput leader of the Bhatti dynasty whose sister was married to Deoraj, a prince of Jaisalmer, India, erected it for military purposes. This ancient fort was the nexus of Rajput and Daudputra rivalry in the seventeenth century. It guarded the old trading route connecting Central Asia and the Indian subcontinent. The site was taken from Raha Rawal Singh of Jaisalmer by the Abbasi ruling family in 1733, when the existing fort was completed. Due to Bahawal Khan's preoccupations at Shikarpur, the fort fell out of the control of the Abbasis in 1747 (Figure 02). Nawab Mubarak Khan took control of the fortress back in 1804. Several structures were erected within and around Fort Derawar throughout the State period (1805–1954), which included a palace, mosque, market, and quarters for the imperial troops, and also the adjoining Abbasi royal cemetery, with its tomb features.

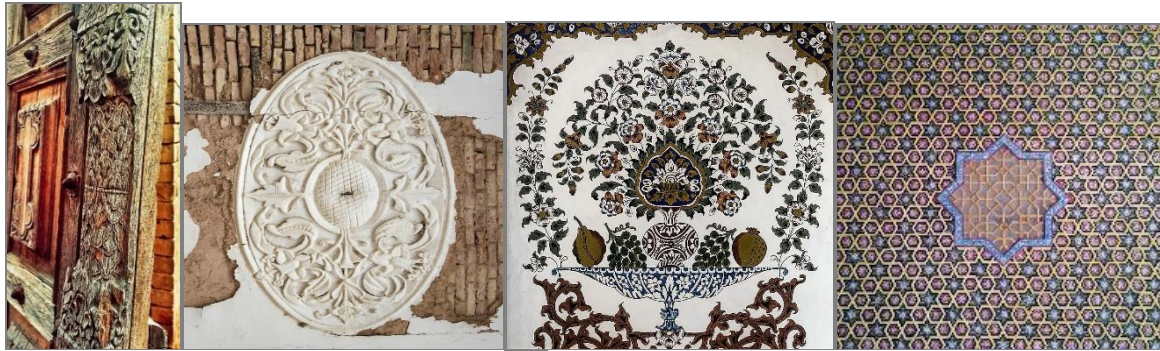
Figure 7-8: Carving on doors panels and decoration on roof

Figure 9-10: Wall paintings of the room were created in compositions with different pairings of fruits and vegetables, as well as floral patterns, indicating oneness and togetherness (Source: Author)

Considering the decoration of buildings (Figure 07 and 08), which is an essential feature of South Punjab's ancient architectural language, as shown in the Derawar fort. The fort's most notable aesthetic feature is the art of wall murals, which has antiquity roots but whose origins are unknown. The Royal Chamber was lavishly decorated with nonfigurative Islamic art from the Islamic tradition (Figure 09, 10 and 14). The frescoes and wall paintings of the room were created in compositions with different pairings of fruits and vegetables, as well as floral patterns, indicating oneness and togetherness, and themes influenced by local flora and fauna, as well as inspiration from outside. Plants in murals have curved leaves that have been decorated in the Iranian manner. Colors and themes were brilliantly blended. Colors for fresco painting were

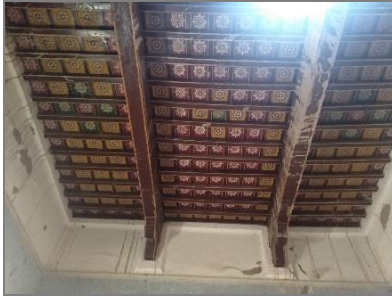
Figure 15: Hardwood ceilings are adorned with Naqaashi work, with floral designs and carvings at the Fort (Source: Author)

All of the fort's buildings were built mainly as load-bearing brick structures with cut and moulded bricks, generally supported by wooden beams, and with carved wooden doors (Figure 11-13), and ventilators. Furthermore, hardwood ceilings are adorned with naqaashi work (Figure 15), with floral designs and carvings. This ceiling was made in some rooms using the traditional tarseem bandi technique (Figure 16), in which small pieces of cut wood are joined with each other in a geometric form by an intricate interwoven joinery.

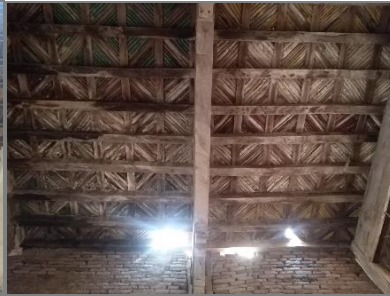
Figure 16: Traditional tarseem bandi technique at the ceiling of the fort's room (Source: Author)

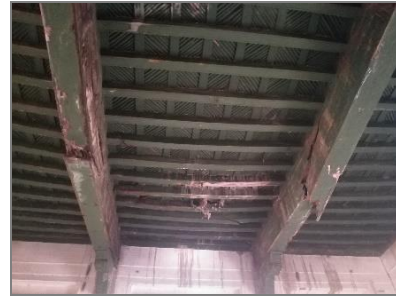
Figure 17: Hardwood ceilings of rooms has been destroyed (Source: Author)

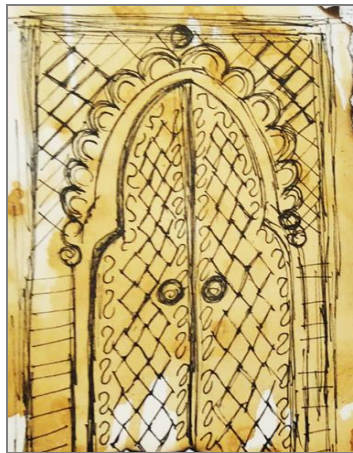
Figure 18: Multi-foiled arches at the fort (Source: Author)

Arches and columns were among the other architectural elements. The fort had three types of arches: one was multi-foiled (Figure 18 and 21), which are distinguished by various circular or leaf forms carved into their inner profile (the name foil originates from the old French word for "leaf"), and the other was semi-circular and pointed arches (Figure 19 and 20). The semi-circular arches at the front of the building were part of the area that was regularly used by the British. These arches form an arcaded veranda in the front, while the arches on the sides are multi-foiled blind arches added by the Mughals. The columns were designed in the manner of Persia and Egypt's ancient columns (Figure 22 and 23). The garden front is pretty ordinary in its arrangement since it provides vistas to all rooms and spaces and adds to the fort's majesty.

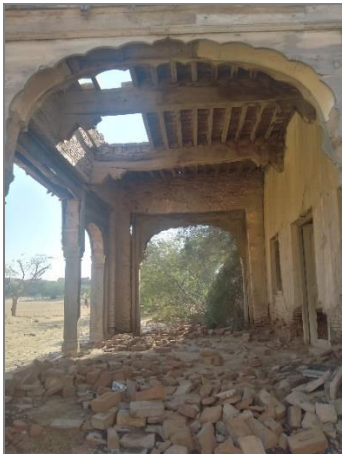
Figure 21: Multi-foiled arches at the fort has been damaged (Source: Author)

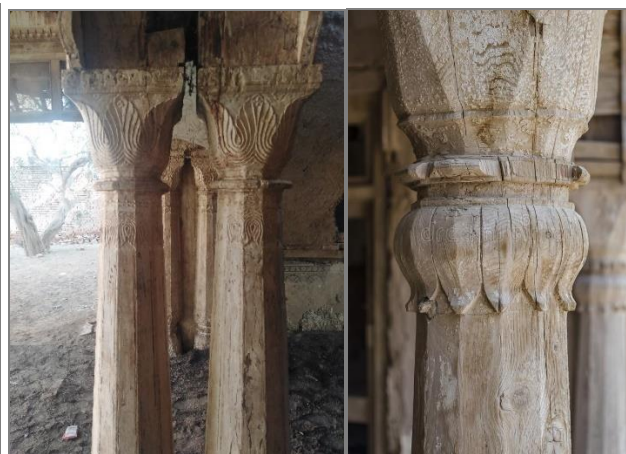
Figure 22-23: Columns of the fort designed in the manner of Persia and Egypt's ancient columns (Source: Author)

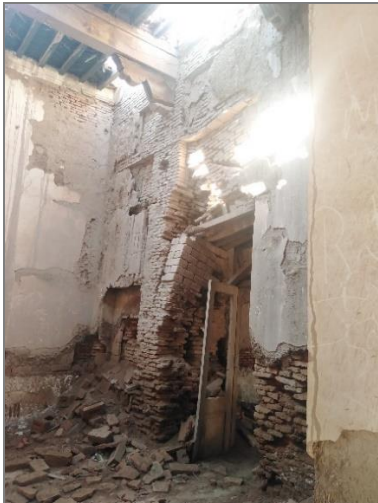
Figure 24: Roof and walls of the room have damaged  
(Source: Author)

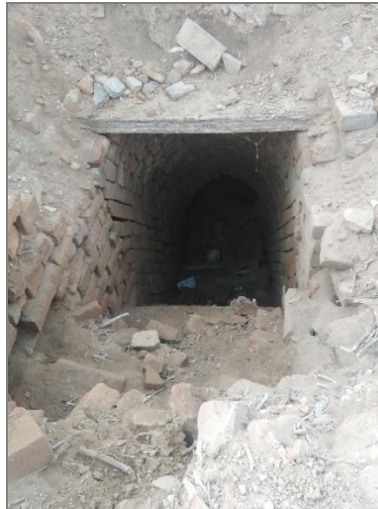
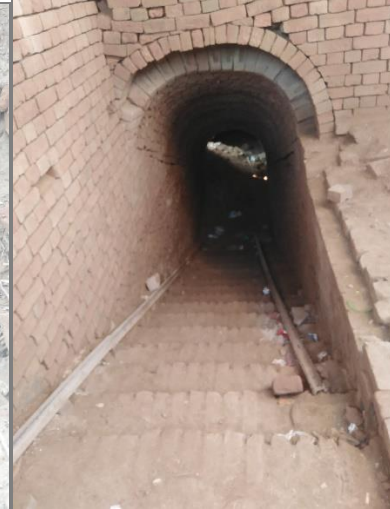
Underground buildings are inaccessible because they have been entirely filled with sand, blocking the pathways (Figure 25 and 26). The 2019 monsoon rains blocked the passageways significantly. Furthermore, three bastions and two pieces of the fort's 80-foot-high, 8-9-foot-thick outer wall had been severely destroyed by harsh weather and time. There are several factors that add to the degradation of fort structures; nevertheless, the following are the most likely causes of fort structures' deterioration. The presence of various organic materials in masonry walls necessitates laboratory testing for bricks and mortar. It is possible that various impurities existed in the original structures have been reintroduced in materials being used for recent repair and restoration works.

Figure 25-26: Underground room has blocked due to rain  
(Source: Author)

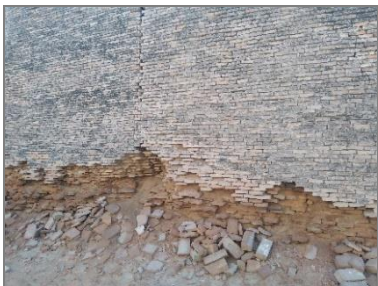
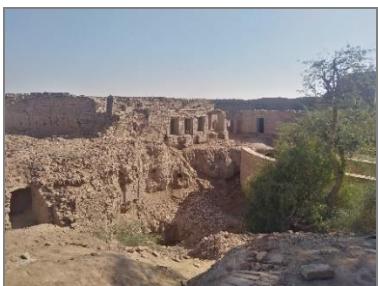
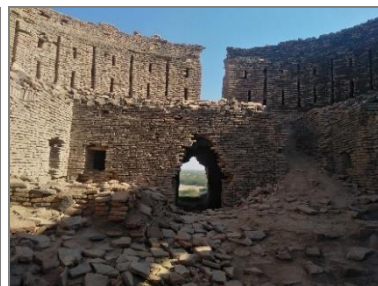
Furthermore, the Cholistan Desert's climate is characterised by strong summer winds. At times, the velocity can exceed 20 miles per hour at times, while the average velocity is around 11 to 12 miles per hour (PCRWR, 2004). Wind pressure at these velocities has had an influence on the fort's buildings. The structures on site are riddled with cracks and holes.

The most damaging consequences of the combination are caused by rain penetrating them and being forced by wind pressure to produce significant interior degradation following saturation of exterior surfaces. In the vicinity of the fort, rainfall is light and infrequent (166 millimetres on average per year). Rain generally falls during the monsoon season (July to September). Monsoon rainstorms are frequently heavy showers (PCRWR, 2004). Rain will cause damage to the brickwork above and below ground level, as well as inside areas, in a variety of ways. Rainwater poured down vertical surfaces after the bricks had been soaked, and wind pressure propelled it through fissures or even through the material itself due to its high porosity. Rain entered the brick walls, causing internal degradation and the formation of holes.

Figure 27-29: Bricks used in the fort's erection currently lie at the bottom of its damaged and cracked outer walls  
(Source: Author)

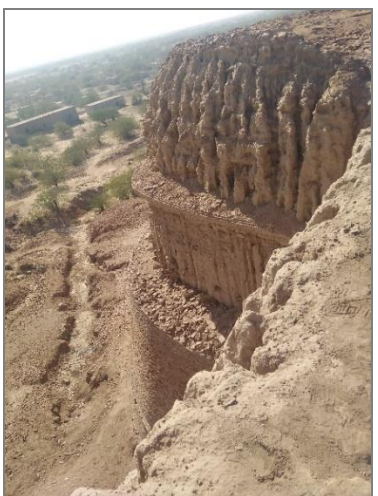
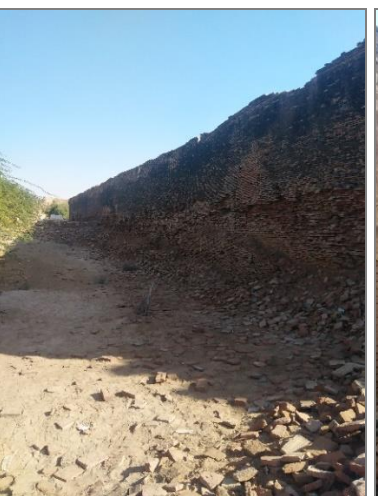
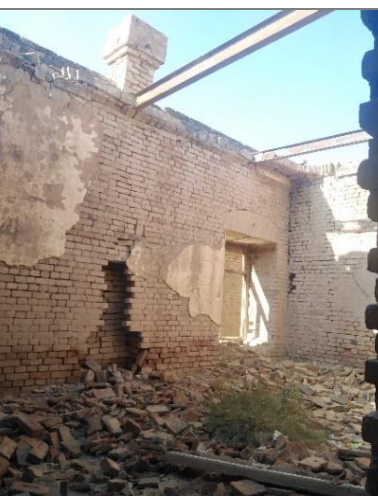
Furthermore, the groundwater in the desert is typically saline (PCRWR, 2004), and rising damp is a common phenomenon and a key cause of deterioration in construction materials, particularly when combined with high salt concentrations. Even if it is minor, it can induce a variety of deteriorating forms. As per its quality "chemical composition," saline groundwater is identified as the most significant factor that can impact the high level of harm to various materials and lead to a variety of deteriorating forms.

Figure 30-32: Bricks used in the fort's erection currently lie at the bottom of its damaged and cracked outer and inner walls  
(Source: Author)

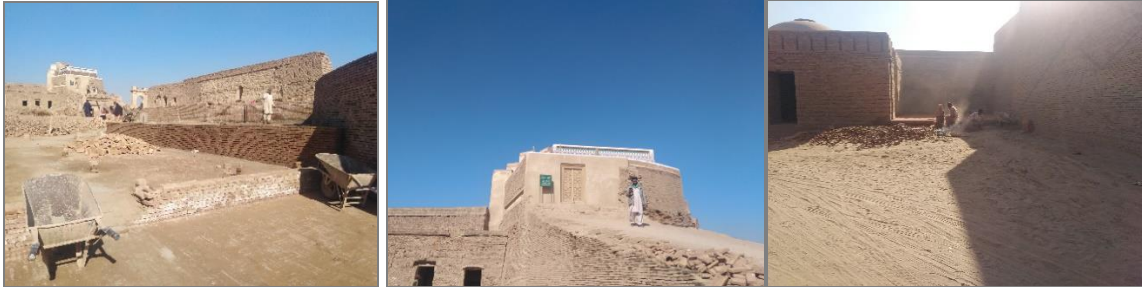
Figure 33-35: Preservation and Restoration of Derawar Fort is in progress  
(Source: Author)

In recent years, the government of Pakistan's Department of Archaeology has undertaken a number of conservation measures to preserve this legacy (Figure 33-35). In 2017, the Directorate General of Archeology and the Government of the Punjab executed a project titled "Preservation and Restoration of Derawar Fort, District Bahawalpur," which was funded by the "Youth Affairs, Sports, Archeology & Tourism Department, and the Government of the Punjab,." The general public, local and foreign tourists, and stakeholders, including Ar. Maqsood Ahmad, Director of the Directorate General of Archeology in Punjab, and Engr. Sajjad Ahmad, SDO of the Directorate General of Archeology in Punjab, are project beneficiaries. On July 20, 2017, the project was authorised for a PC-I sum of Rs. 101.600 million, which was later amended to Rs. 115.742 million on December 18, 2018. However, up to August 20, 2021, actual expenditure was Rs. 76.030 million, indicating a financial utilisation of 65.7 percent (Zia, 2021).

The exterior of the fort's wall is currently being adversely damaged by salt and is crumbling down in numerous parts. Therefore, preservation work has been divided into phases. The salt-affected bricks were removed in the first phase, and underpinning work was carried out using special-sized bricks, and a 19-foot wide portion of the boundary wall and the 62-foot deep bastion of the Derawar Fort were repaired up to a height of 75 feet (Figure 36). Furthermore, partial preservation works include the restoration of the front of the south-eastern and north eastern fort bastions, the first entry gate, the interiors of the fort, a Mosque (Figure

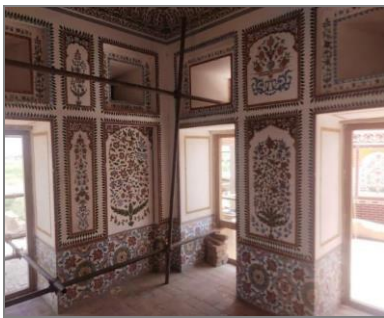
Figure 36: Preservation and restoration of the approach and interior of Bara Dari has been done  
(Source: Author)

37), the approach and interior of Bara Dari (Figure 38), and the Godowns. The godowns were maintained at the project site, but diagonal lines were added to the final outside surface of these godowns. Since preservation is required to be done in accordance with the original pattern and design, and because there was no trace of such a pattern before the conservation tasks were undertaken there, the presence of such additional patterns indicates a deviation from the original design. Furthermore, work progress is slow, which may cause delays in the project's date of completion.

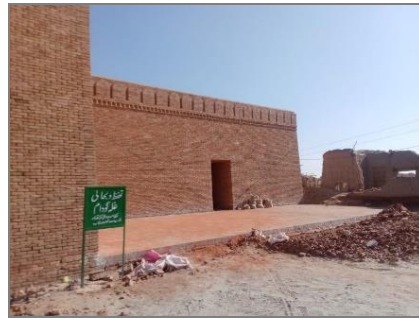
Figure 37: Preservation and restoration of the Mosque has been done  
(Source: Author)

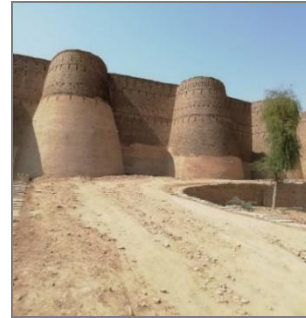
Figure 38: 62-foot deep bastion of the Derawar Fort has been repaired up to a height of 75 feet  
(Source: Author)
