# PAKISTAN HERITAGE

# Mughal Monuments at Palosi Piran, Peshawar: Report on Its Recent Conservation and Restoration 2021-22

ABDUL WAHAB AND ZUBAIDA YOUSAF

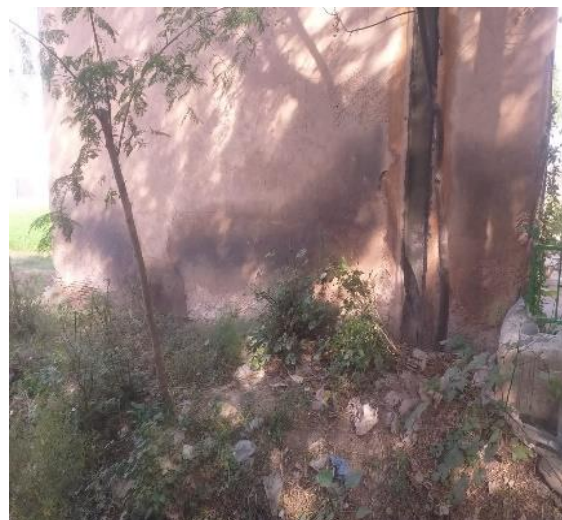
The building was surrounded by wild growth i.e. shrubs and trees (Pl. 2). The wild grass was causing surface deterioration. Apart from this, there is irrigation land on the western side of the mosque. This, when irrigated, was making dampness and thus causing weakness of the building, particularly the foundations.

**Plate 02.** Wild Growth Before Conservation

The conservation work started with the removal of grass and trees near the building of the mosque. The shrubs that were positioned too close to the building's foundation were removed and the trees were cut down. This will allow for better water flow and prevent water from pooling at the base.

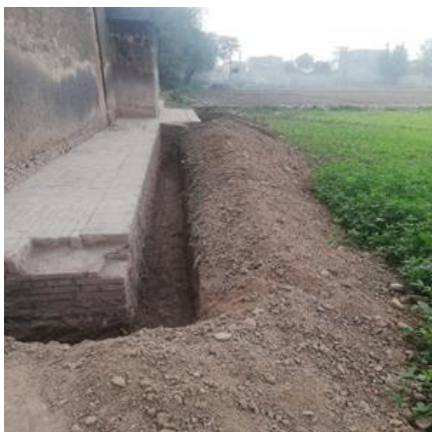
First, measures were taken to protect and strengthen the foundation. All external sides of the prayer chamber were dug up to 3 feet (Pl. 3). The area on northern and southern sides was equal in length, each measuring 25 feet. The digging of western side was carried out in three portions, *Mehrab* in the center and added by two sides. The center, that is back side of *Mehrab*, measures 17 feet while the other two sides measure 50 feet (25 feet each side). Hence the western side measures 67 feet. Therefore, a total of 117 feet area was excavated. The excavated portion was re-filled with concert. First a bed of 4 inches was laid to make the virgin level solid (Pl. 4). After this, the excavated area was filled up to 6 inches in width (Pl. 5).

**Plate 03.** Exposed Platform After Excavation

The purpose of this was to strengthen and protect the foundation. On the western side, there is irrigation land. When the crop was irrigated, the dampness reached to the bottom of the structure and it could cause weakness of the base. Beside this, there is a small water channel on south side that runs part time, but the dampness was, no doubt, causing damage to the foundation. Apart from this, the gullies were also worn out and the rainy water were drained through the walls. At the bottom of the wall, the shrubs were grown and it would not allow the water to flow through and the water would reach to the base. Now the bed of concert will not allow the water to go through and reach to base.

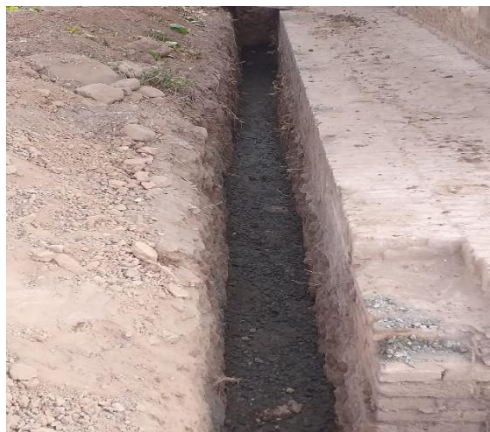
**Plate 04.** Bed of Concrete

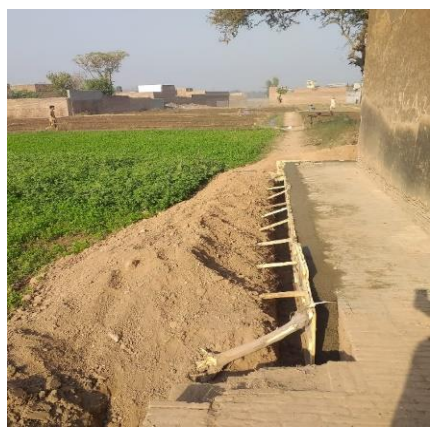
**Plate 05.** Platform After Concrete Filling

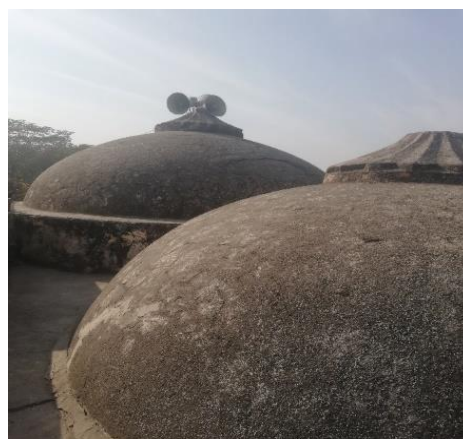
The domes of the mosque were in a more precarious condition than the other parts of the mosque (Pl. 6). There are three domes over the prayer hall of Palosi Piran's mosque. The central one being larger than the other two, one each at north and south side. At most of the places cracks were developed and were propagating inside, creating a serious threat to the structural elements.

**Plate 06.** Domes Before Conservation

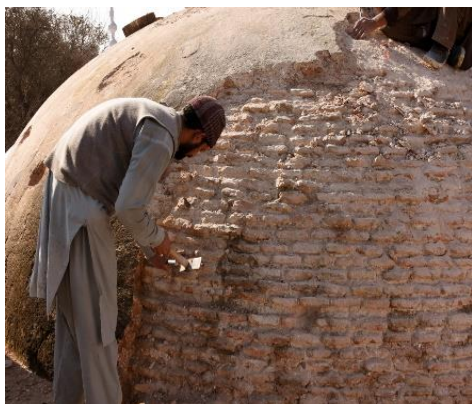
Overload material pressure was reduced by removing the entire loose material from the surface of the domes (Pl. 7). It was not possible to apply more material over the previous one, this would overload the dome.

**Plate 07.** Removal of Loose Material from Dome

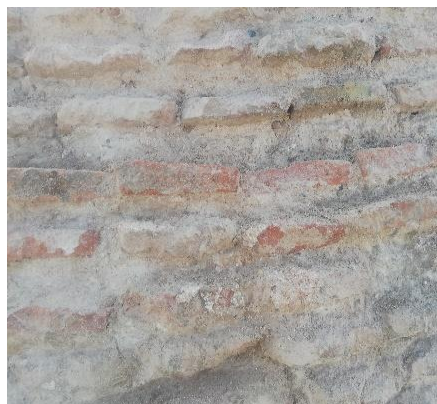
The domes were consisting courses of bricks with a heavy pilaster. The bricks were bonded through thick and thin layers of lime mortar between them. The mortar consisted of lime, tiny brick pieces and various additives to enhance different properties of the mortar. The space between the courses of bricks was 1 to 2 inches (Pl. 8).

**Plate 08.** Gap Between Burnt-bricks Course

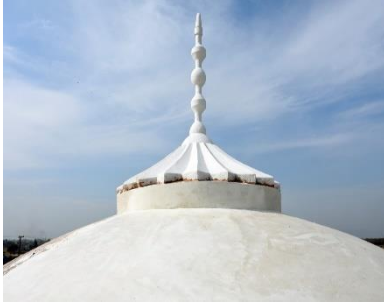
**Plate 09.** Dome After Conservation

After removal of the existing loose material, fresh material was applied over the domes. The fresh plaster is comprised of limestone, marble powder, super marble powder, *surkhi*, jewt/*sund*, and acrylic. The first slip, given to the domes, was that of *surkhi*. This slip was supposed to fill the gap between the courses of bricks. It was followed by another slip which contains grass (straw for reducing cracks). Above this another slip of *surkhi* was applied which would make the surface a bit smooth. After this a layer of limestone was applied to make the surface smoother. At the end *pucca qalai* was applied that make the dome shiny (Pl. 9).

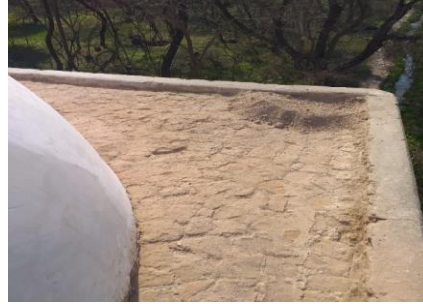
The first layer of the floor consisted of stucco and *surkhi*. Above this, broken bricks, likely remnants from the construction of the domes were placed (Pl. 10). These broken bricks are of the two types; one is yellowish and the other is reddish, bind with stucco, *surkhi* and earth. Above this was a final slip of stucco, *surkhi* and a small quantity of earth (Pl. 11). The eastern side of the northern dome was roughly made. It was made of broken bricks and irregular shape stones. Earth was also frequently used in this portion (Pl. 12). It was either done with carelessness or made by some unskilled mason. It is also probable that this portion was damaged earlier and was restored by local people having no knowledge of original floor or had no sources, or both.

**Plate 10.** After Removal of Surface Material from  
the Floor

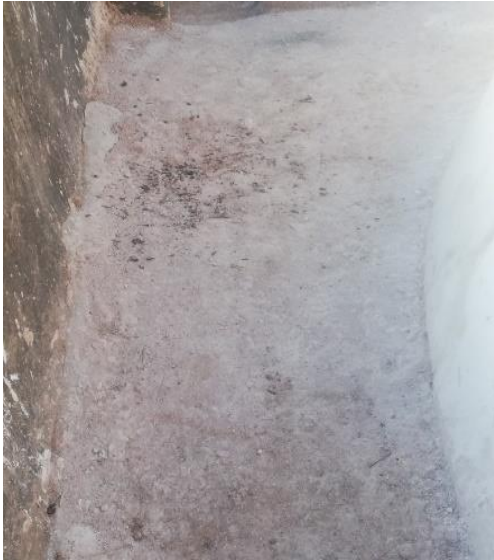
**Plate 11.** Floor Before Conservation

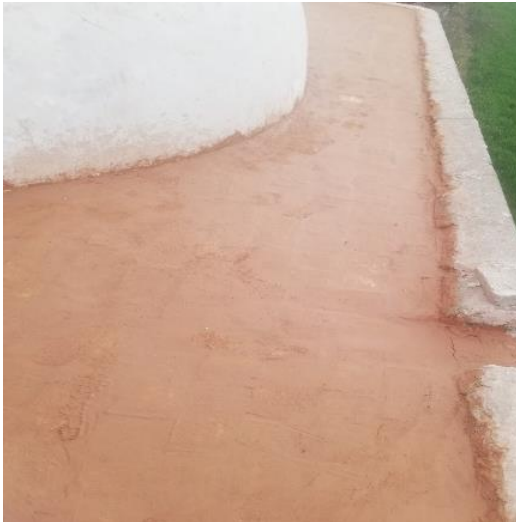
**Plate 13.** Floor After Conservation

The floor was in a damaged condition and needed conservation on immediate bases. The top loose material of the floor was removed. This was replaced with the similar material. Above this burnt bricks (*chauka*) is paved and the gap between the bricks, in the shape of small lines, was filled with *surkhi* (Pl. 13). In addition, the water outlets were repaired to channelize the rainy water in a flow.

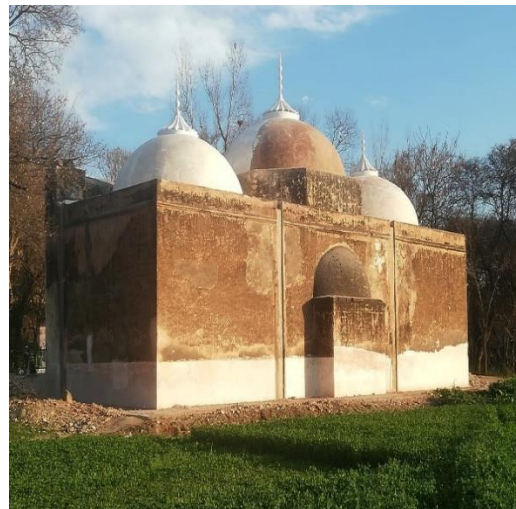
**Plate 14.** The Outer Side of Walls

The outer walls, about three feet in height, were also deteriorated due to weathering. These walls were also conserved with the similar material. Lime mortar plaster was given to outer face of the walls and *Pucca qalai* was applied over them (Pl. 14).
